Third Party Protection Audit at the following Substaions of Resonia:

1. Nangalbibra- Bongaigaon Transmission Limited (Locations: Nangalbibra, Bongaigaon, Hatsingimari & Ampati)
2. Goa Tamnar Transmission Project Limited (Location: Goa)
3. Mumbai Urja Marg Limited (Location: Vapi)
4. Lakadia-Vadodara Transmission Project Limited (Locations: Lakadia & Vadodara)

CENTRAL BOARD OF IRRIGATION & POWER

OBSERVATIONS DURING AUDIT OF 220 kV/ 132 kV NANGALBIBRA SUBSTATION OF RESONIA GROUP

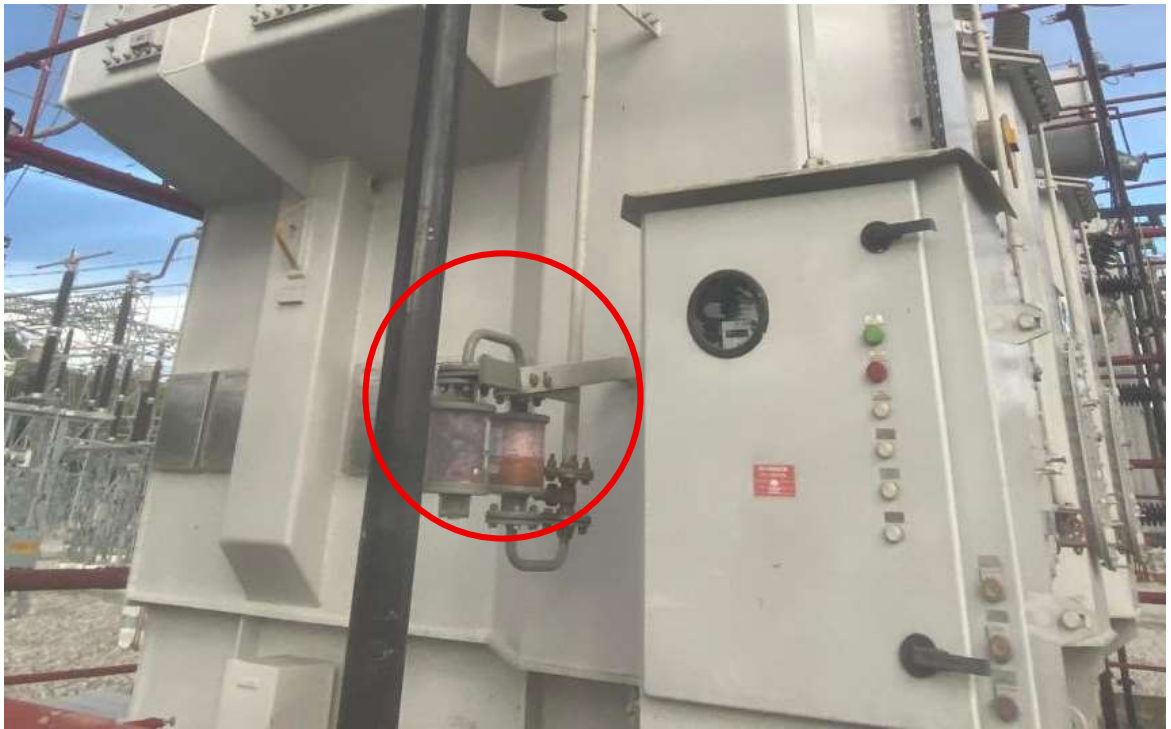
During the site inspection, it has been observed that oil is coming in OLTC breather from OLTC conservator. Further investigation revealed that the transformer's main tank and OLTC tank are communicating with each other, leading to the mixing of main tank oil with OLTC oil. The site manager has informed that the matter has already been taken up with the

manufacturer. This needs to be addressed at the earliest opportunity to avoid the mixing of main tank oil and OLTC tank oil.

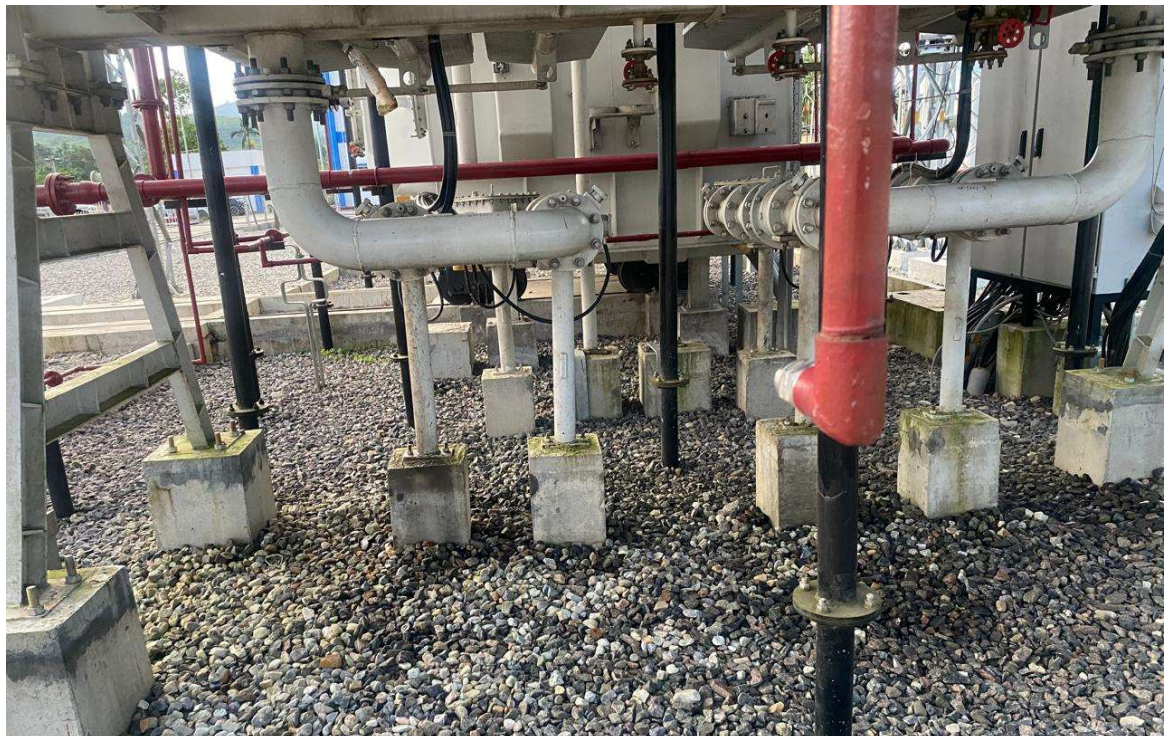
It was also observed that there was seepage of oil from oil headers and cooling accessories of the main tank of ICT-1 and ICT-2. This also need to be arrested in due course of time.

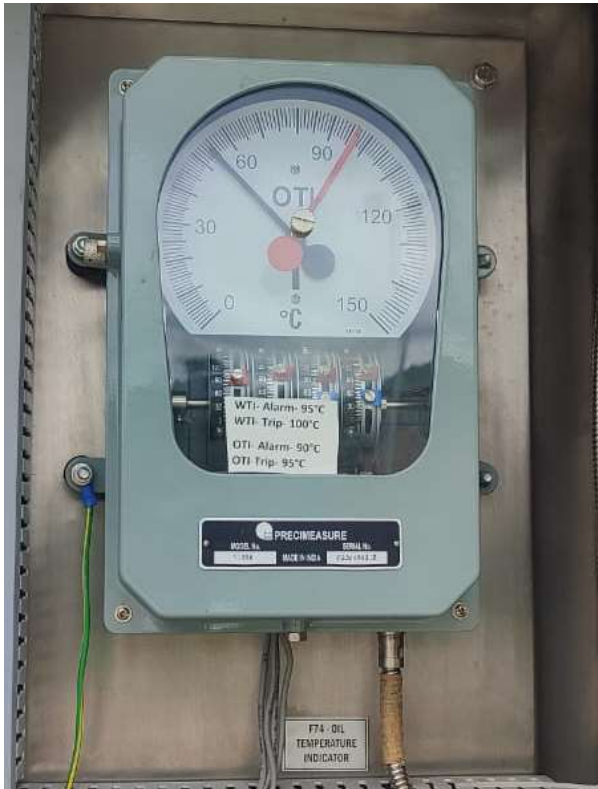
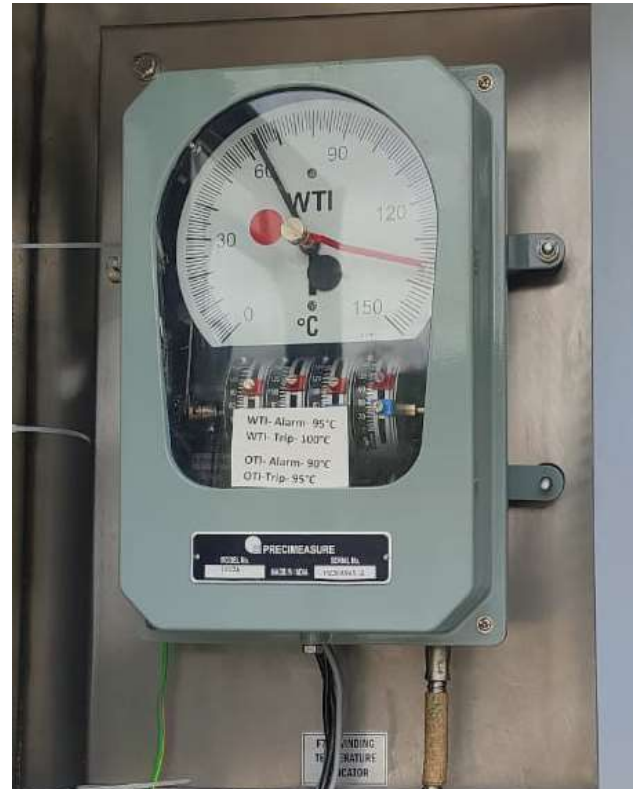
It is observed that Maximum Temperature of Winding Temperature Indicator (WTI) And Oil Temperature Indicator (OTI) of 160 MVA 220 / 132/ 33 ICT- 1 and ICT- 2, 31.5 MVAr 220 Bus Reactor-1 and Bus Reactor-2 have gone beyond 130°C. This seems to be erroneous. It may so happen that pointer was manually operated during maintenance checking of Alarm/ Trip circuit of respective device. Maintenance Engineer needs to reset the maximum temperature indicator after testing.

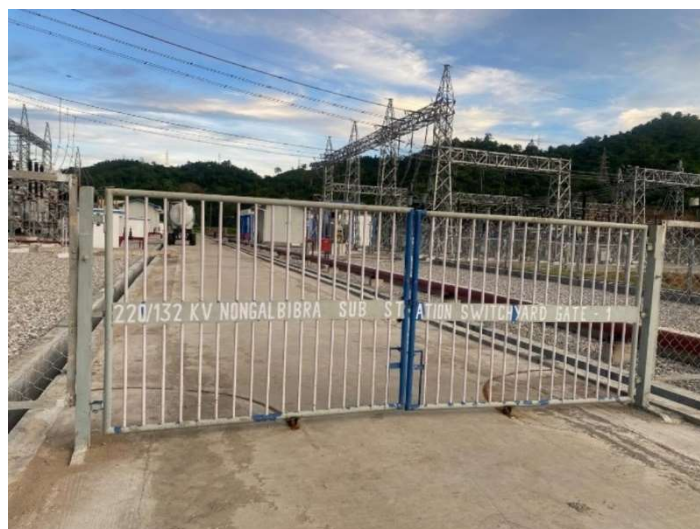
Proper Earthing of Switchyard Gates has to be provided. In this regard IEEE 80 recommends as under:

“The ground grid should extend to cover the swing of all substation gates. Gate posts should be securely bonded utilizing a flexible connection”.

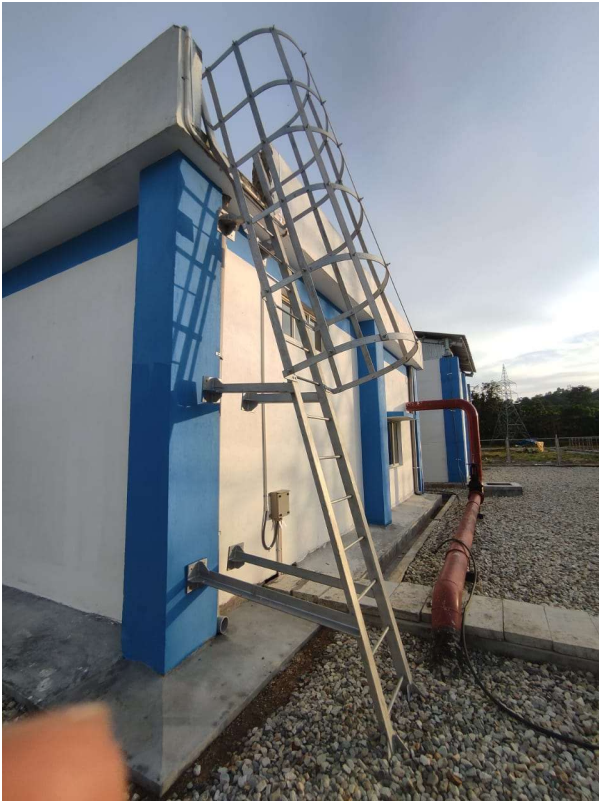
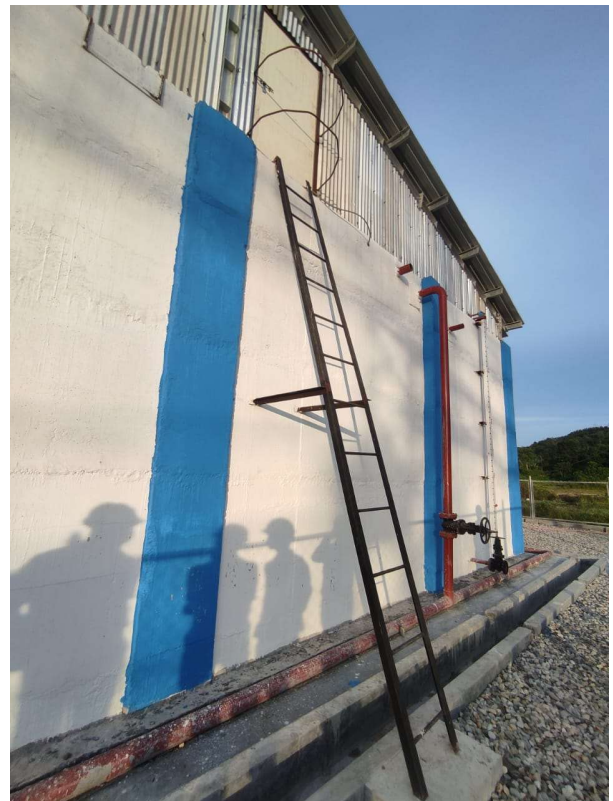
Earthing of ladders in the substation needs to be ensured. All metallic structure/ enclosure/ non-current carrying parts need to be earthed. The ladders should also anchored properly on the supporting walls.

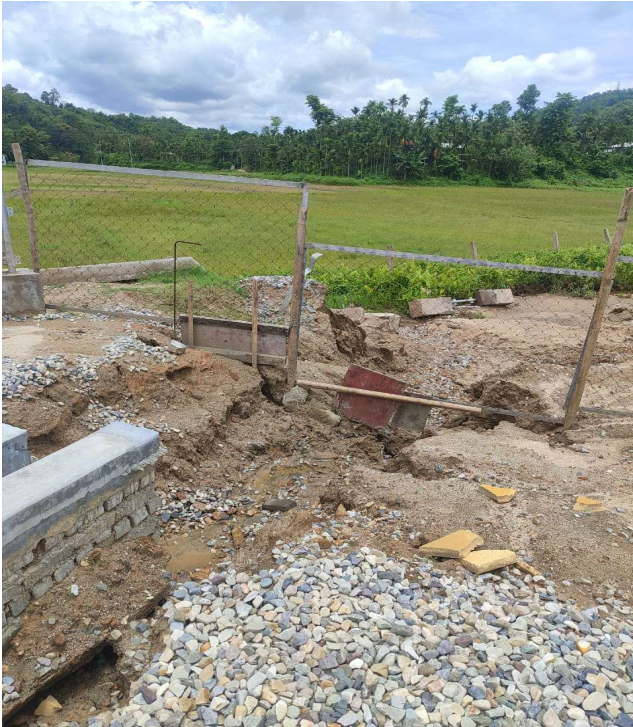
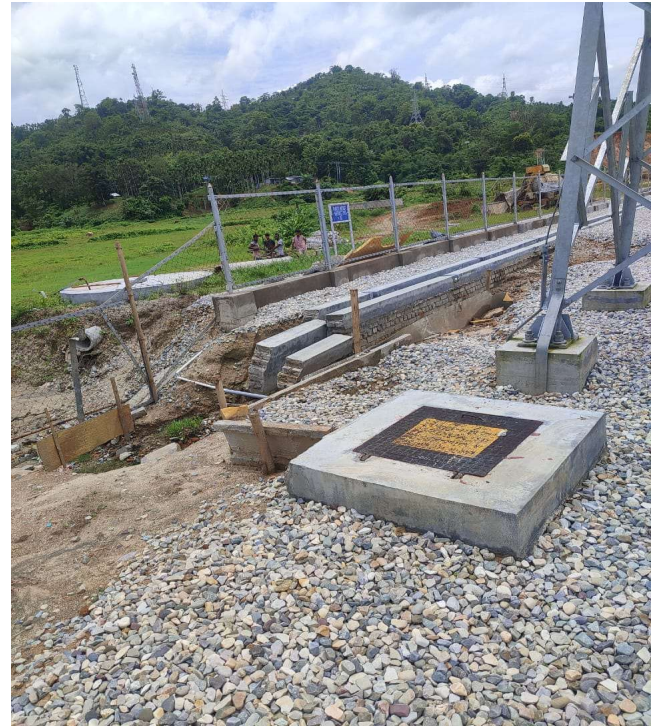
The substation is present in Meghalaya which is a very heavy rainfall inundated state. As such, the audit team observed that the outer periphery wall of the substation was damaged due to the soil erosion caused by the rain water getting collected and consequent loss of soil strength. Temporary restoration for security of the site has been taken up by the site management. However, for permanent solution this needs to be taken up at the management at the earliest as the erosion was seen adjacent to the foundation of gantry tower.

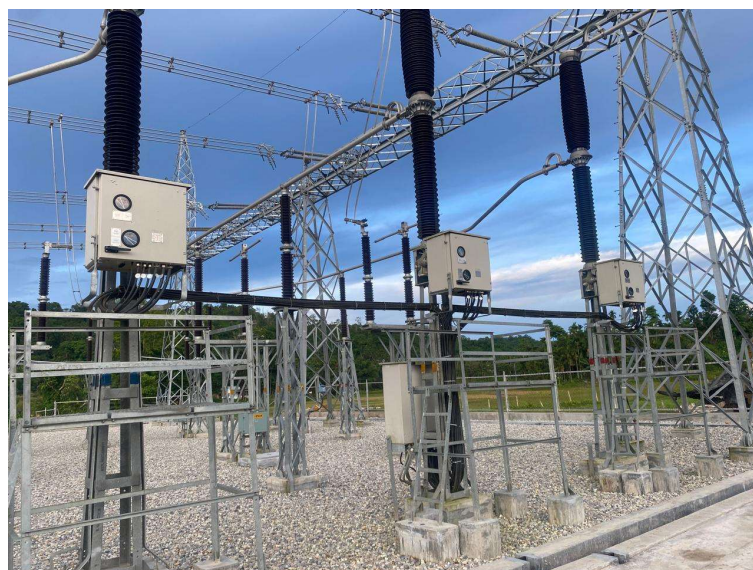
During the site visit, it was observed that switchyard equipment identification is existing but the operating box of CB may also be suitably marked for easy identification of the particular bay CB.

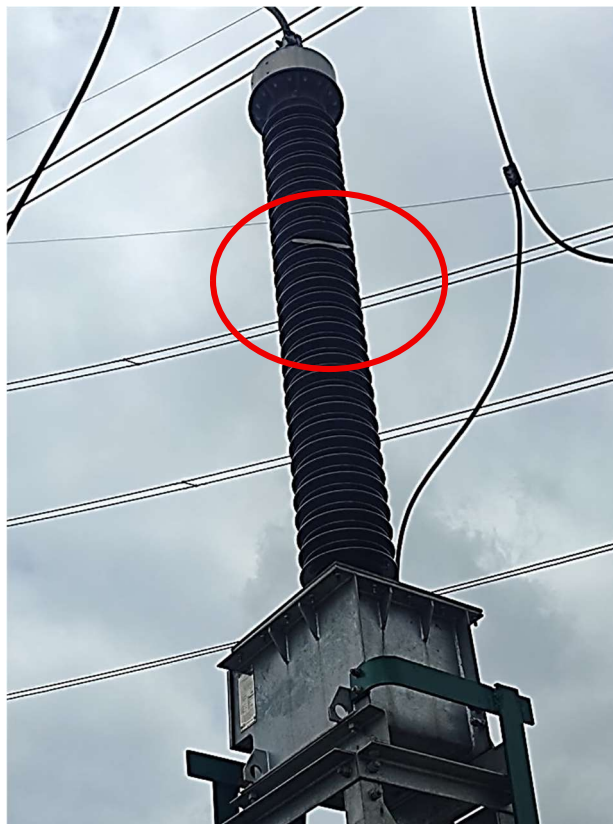
During switchyard visit, it was observed that chipping has occurred (damaged petticoat) on porcelain insulator housing of R phase CVT. It is advised to repair it to avoid ingress of moisture so as to ensure healthiness of CVT.

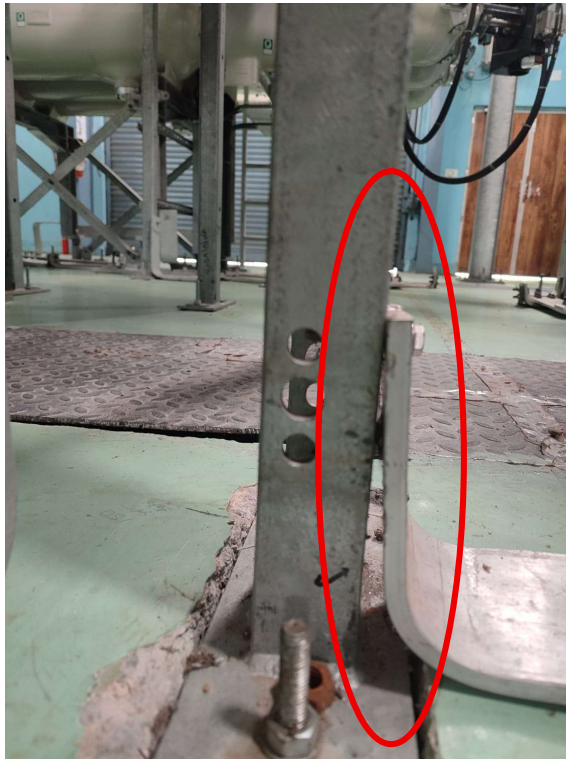
Earthing of GIS structure of NBTL bays was inspected, it was observed that earth strip was not making proper contact with the support structure near Nangalbibra Ckt-1 bay. Since, earthing of equipment is of paramount importance for safety, it is recommended to get it rectified at the earliest opportunity.

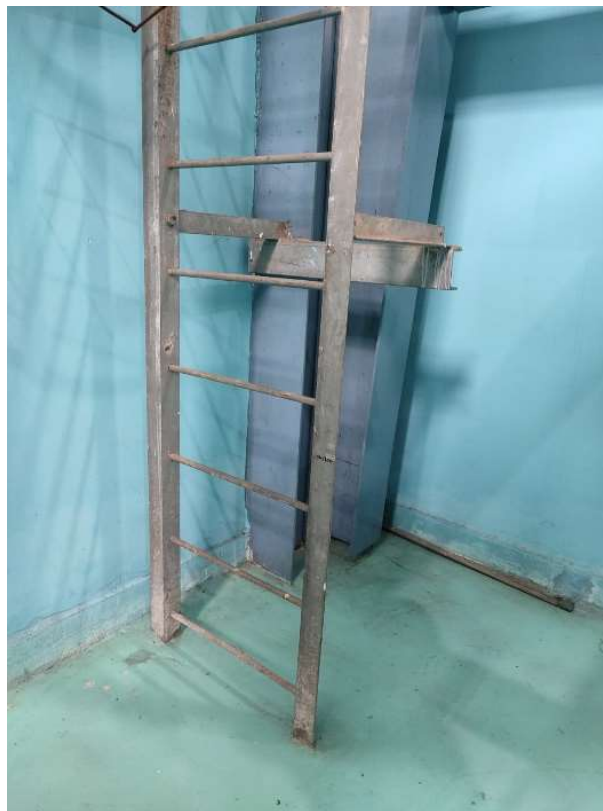
Earthing of ladders in the GIS hall needs to be ensured. All metallic structure/ enclosure/ non-current carrying parts including Rail, Signage Boards, Ladder, Metal Box/ cubicle etc. need to be earthed.

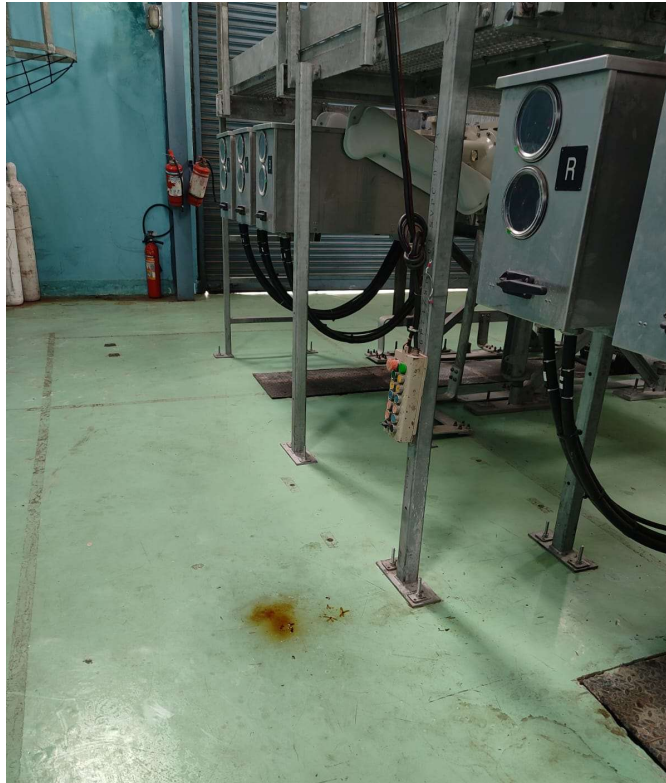
During GIS hall inspection, it was observed that oil is spilled on the floor near 220 kV Nangalbibra Line Bays. It needs to be avoided to prevent any injury to operating personnel.

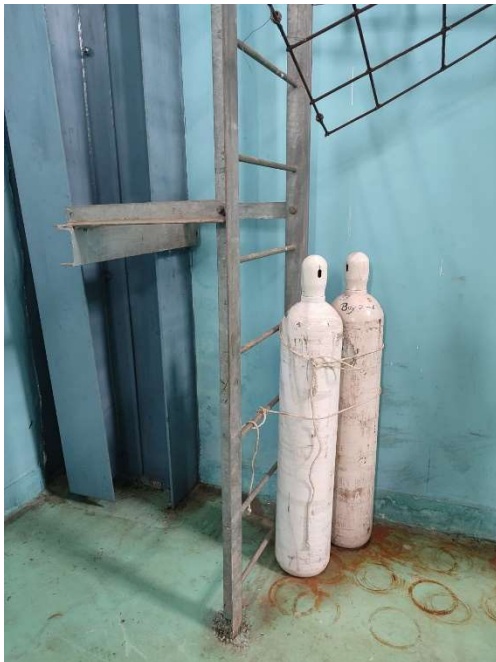
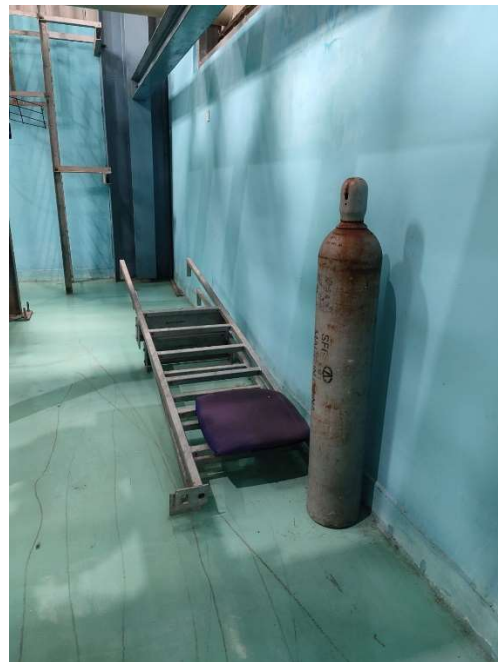
It was also observed that SF₆ gas cylinders are present in the GIS hall but proper demarcation is absent to distinguish the filled and empty cylinders as empty cylinders should be removed from the GIS room.

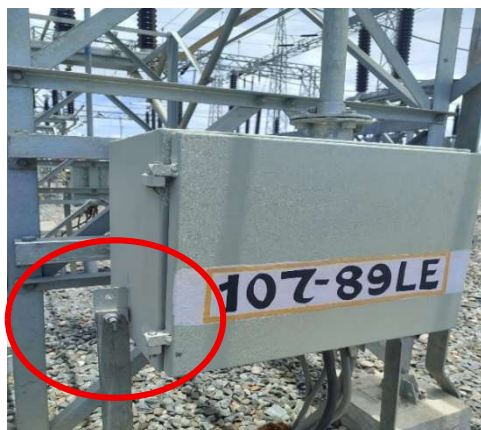
Drive mechanism box of Isolators and Earth Switches may not be earthed by rigid connection with earth strip, instead flexible braided link may be used between the earthing terminal of mechanism box and GI earth strip.

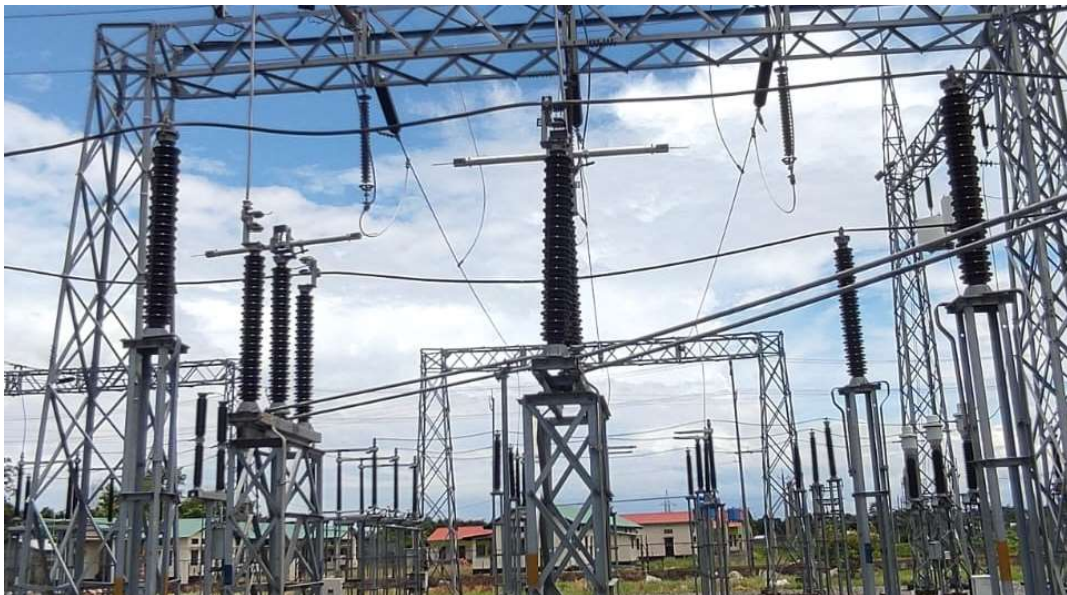
The alignment of tandem isolators (Transfer bus isolator of Ckt-1) at Hatsingimari substation seem to be improper/ off-centre and needs proper alignment for operation of isolator and good contact penetration. Since, they were in open position, hence whether they make proper contact when closed couldn't be verified. It is suggested to get them re-aligned and ensure that proper contact is being formed. Thermo-vision scanning may also be done to ensure proper male-female contact.

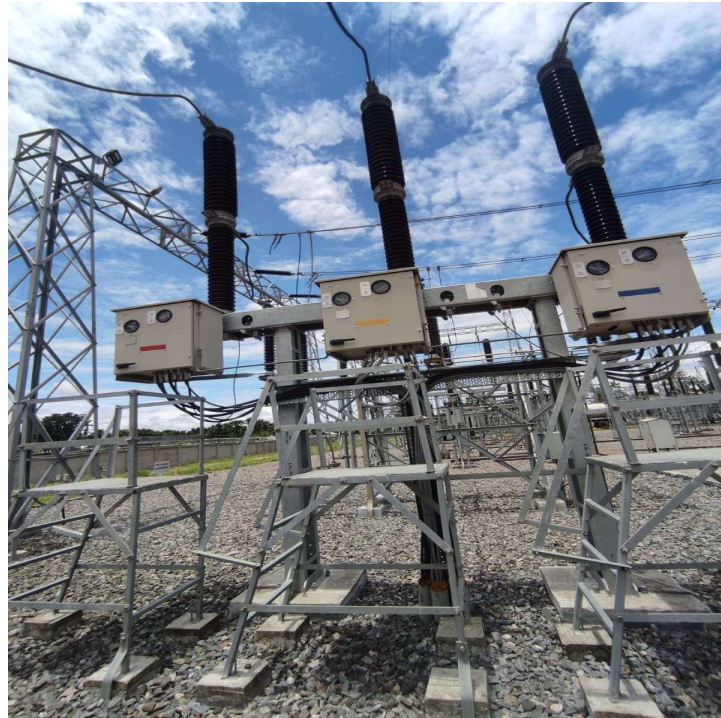
During the site visit, it was observed that switchyard equipment identification is existing but the operating box of CB may also be suitably marked for easy identification of the particular bay CB.

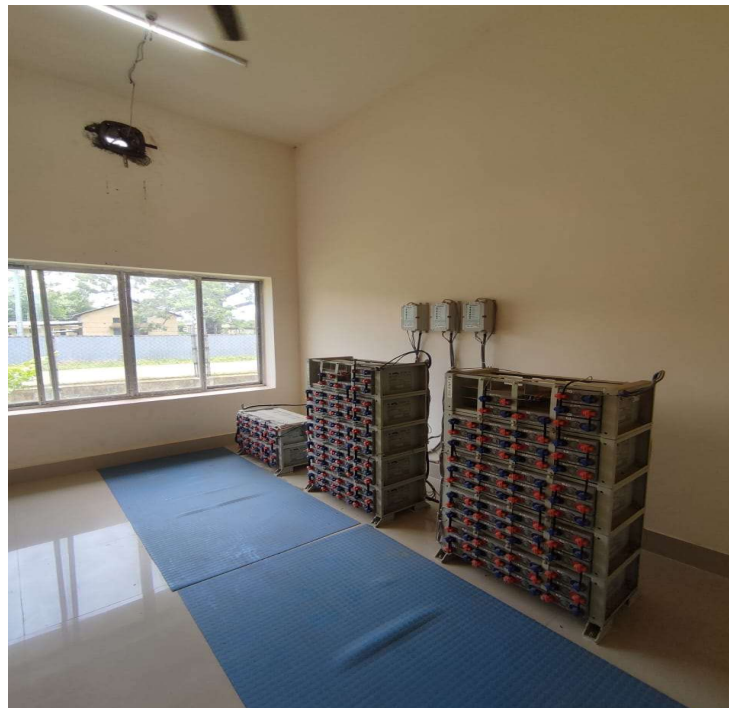
Battery room at Hatsingimari substation doesn't have AC system installed. The ventilation of battery room is dependent upon the running of exhaust fan. Since, the batteries installed are VRLA type, it is suggested to get AC installed in the Battery room as per manufacturer recommendations of having controlled temperature for prolonging the life of VRLA battery.

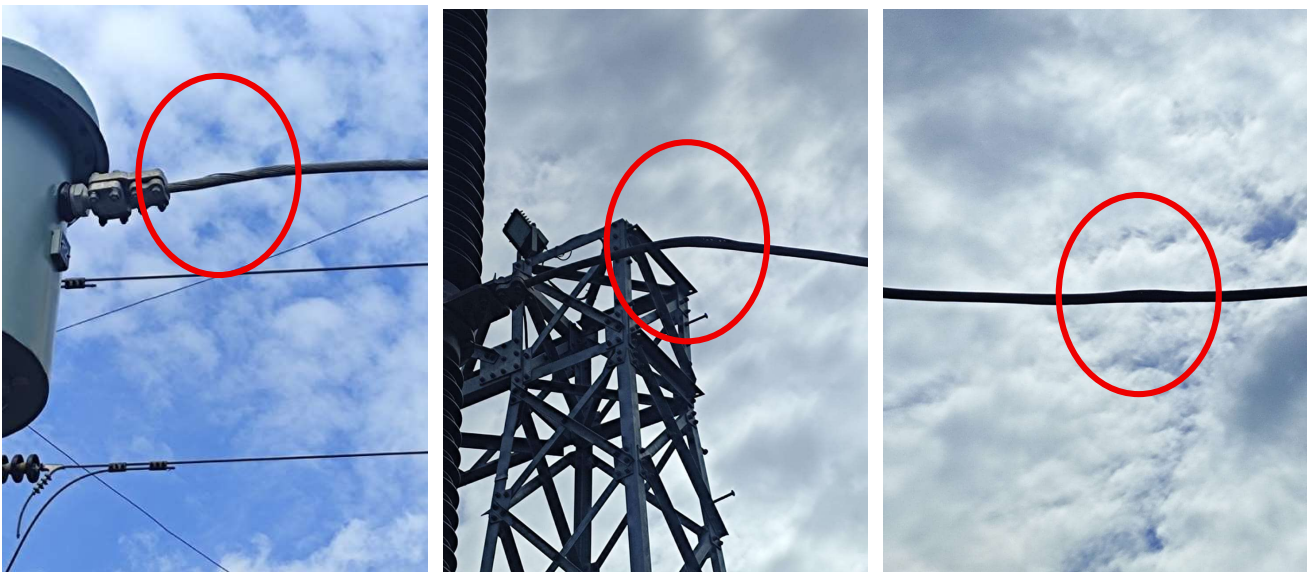
Thermo-vision scanning of substation equipments has not been undertaken by NBTL personnel since charging of the substation. During switchyard visit, it was observed that few strands of conductor have got loose near terminal connector of some equipments. Thus, it is inferred that due to hot-spots, the conductor strands have gotten loose. Hence, it is recommended to get the Thermo-vision scanning of the bay equipments be done at the earliest opportunity to identify and rectify the loose connection/ hot-spots on every equipment of the substation.

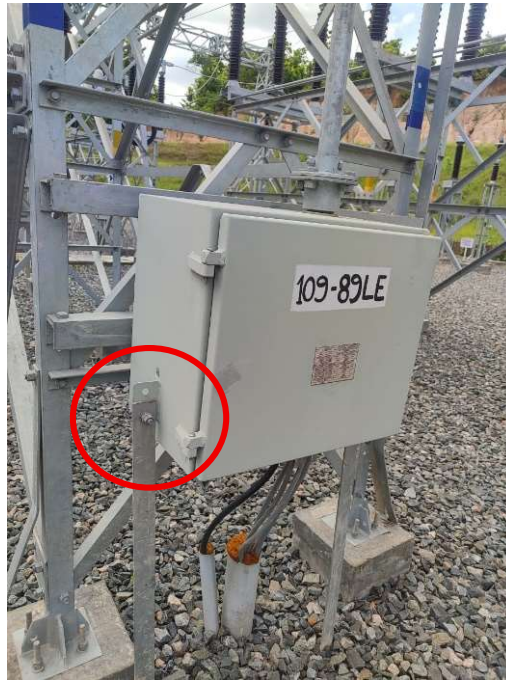
Drive mechanism box of Isolators and Earth Switches may not be earthed by rigid connection with earth strip, instead flexible braided link may be used between the earthing terminal of mechanism box and GI earth strip.

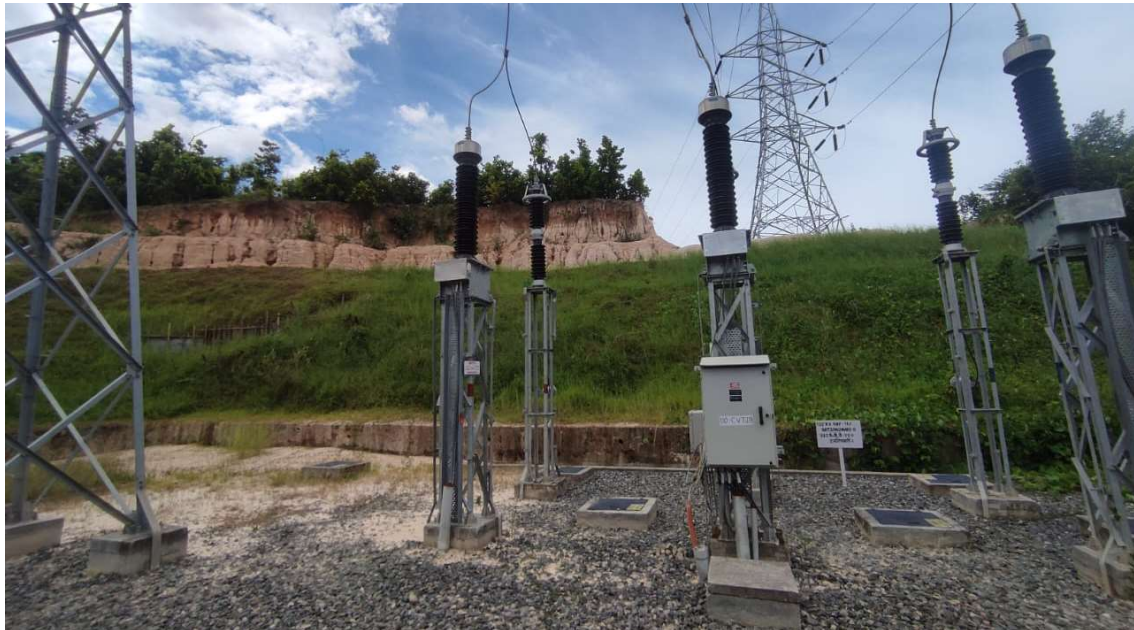
Soil erosion was found near the LAs of the 132 kV bays. It is suggested that some sort of retaining wall be provided in the concerned area to avoid further soil erosion and to safeguard the bay equipments.

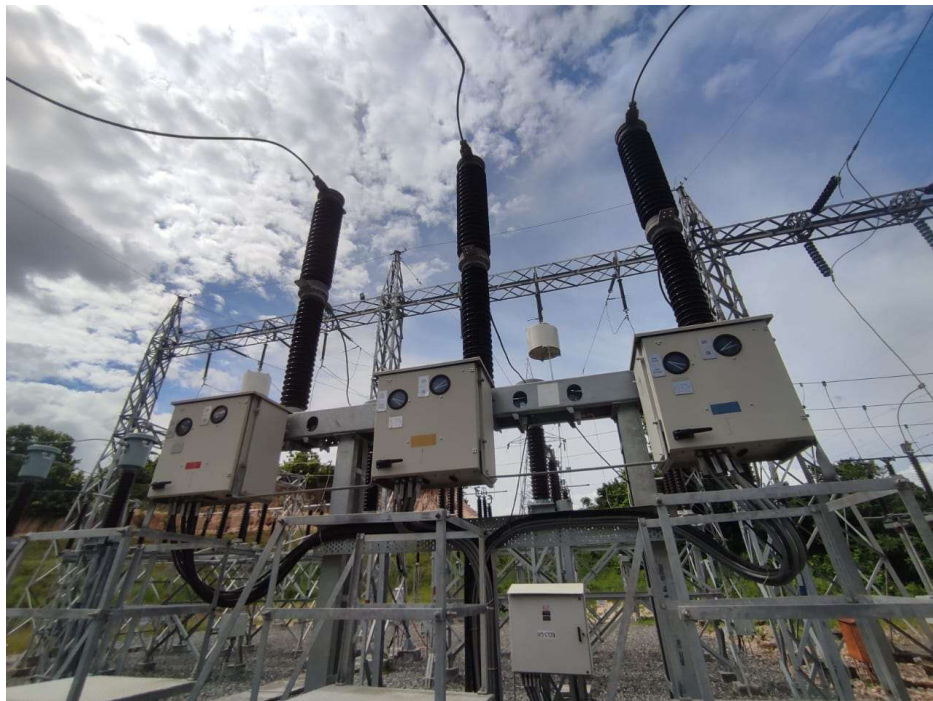
During the site visit, it was observed that switchyard equipment identification is existing but the operating box of CB may also be suitably marked for easy identification of the particular bay CB.
